# NASA-DoD Lead-Free Electronics Project

DoD Soldering Technologies Working Group (STWG)

August 24 - 25, 2010

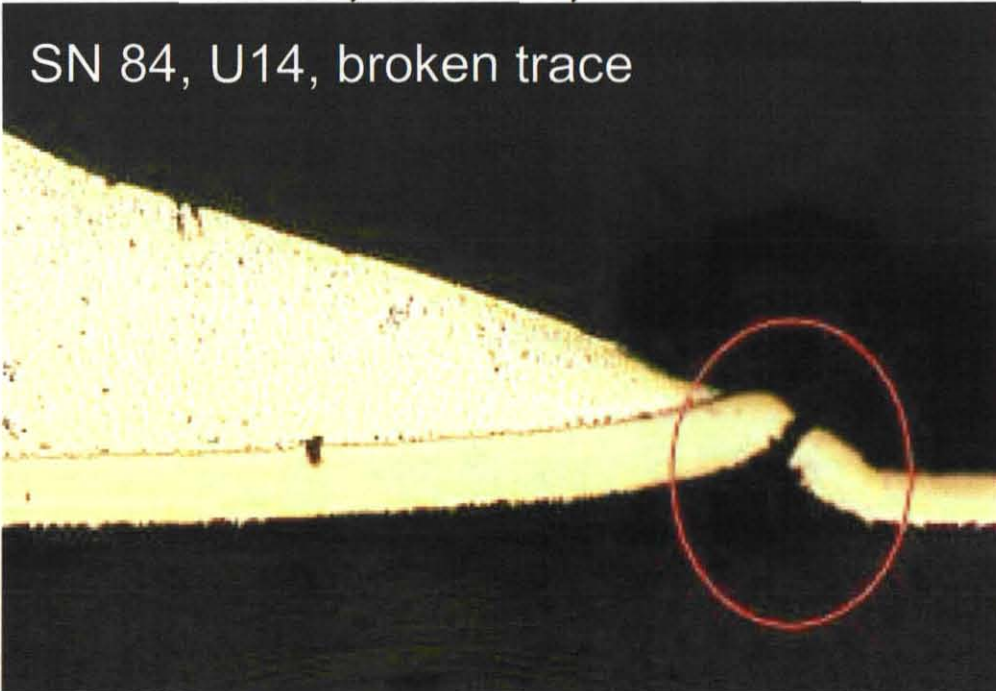
SN 84, U14, broken trace

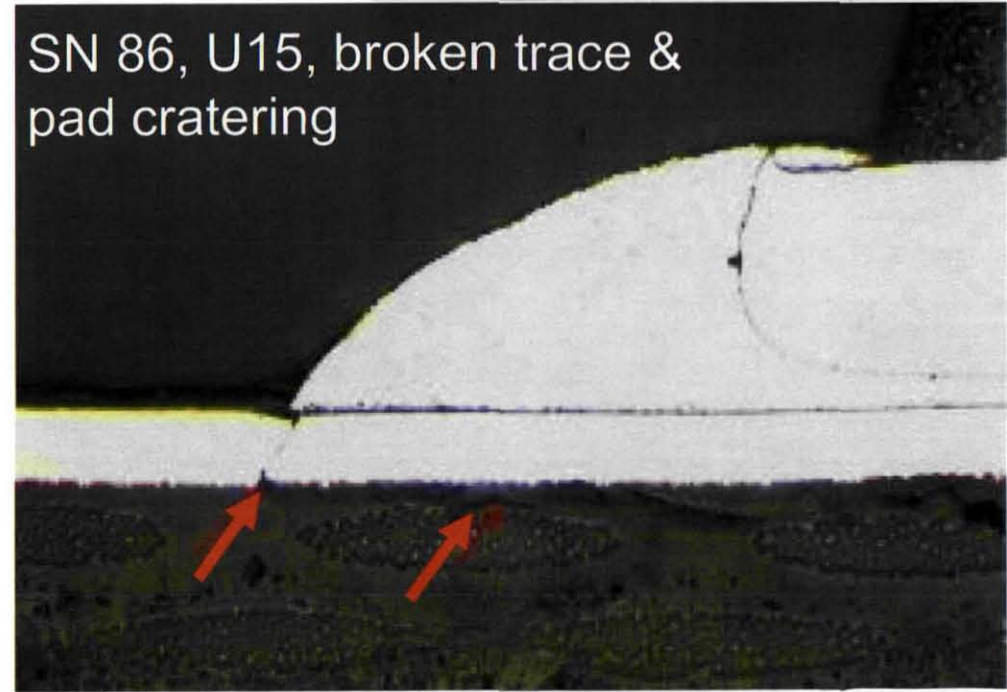
SN 86, U15, broken trace & pad cratering

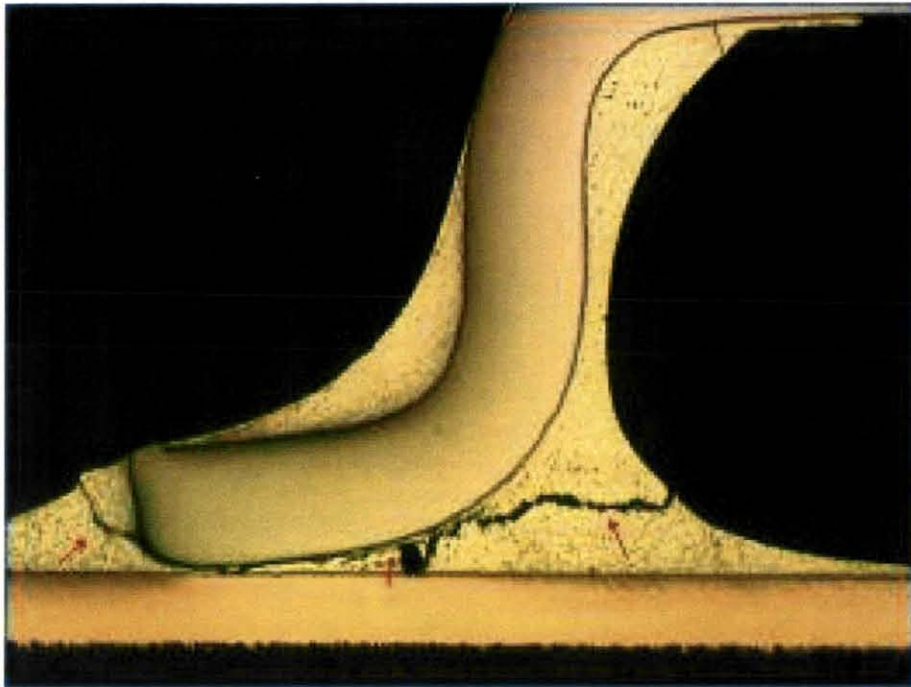
SN67, U61, left lead solder crack, 100x

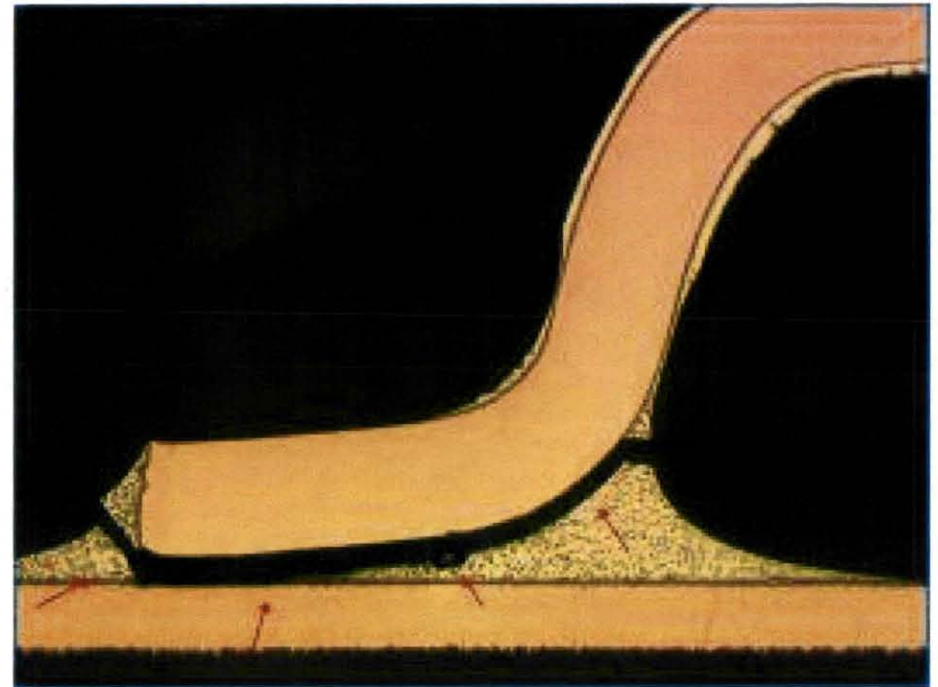
SN67, U31, left lead solder crack, 100x

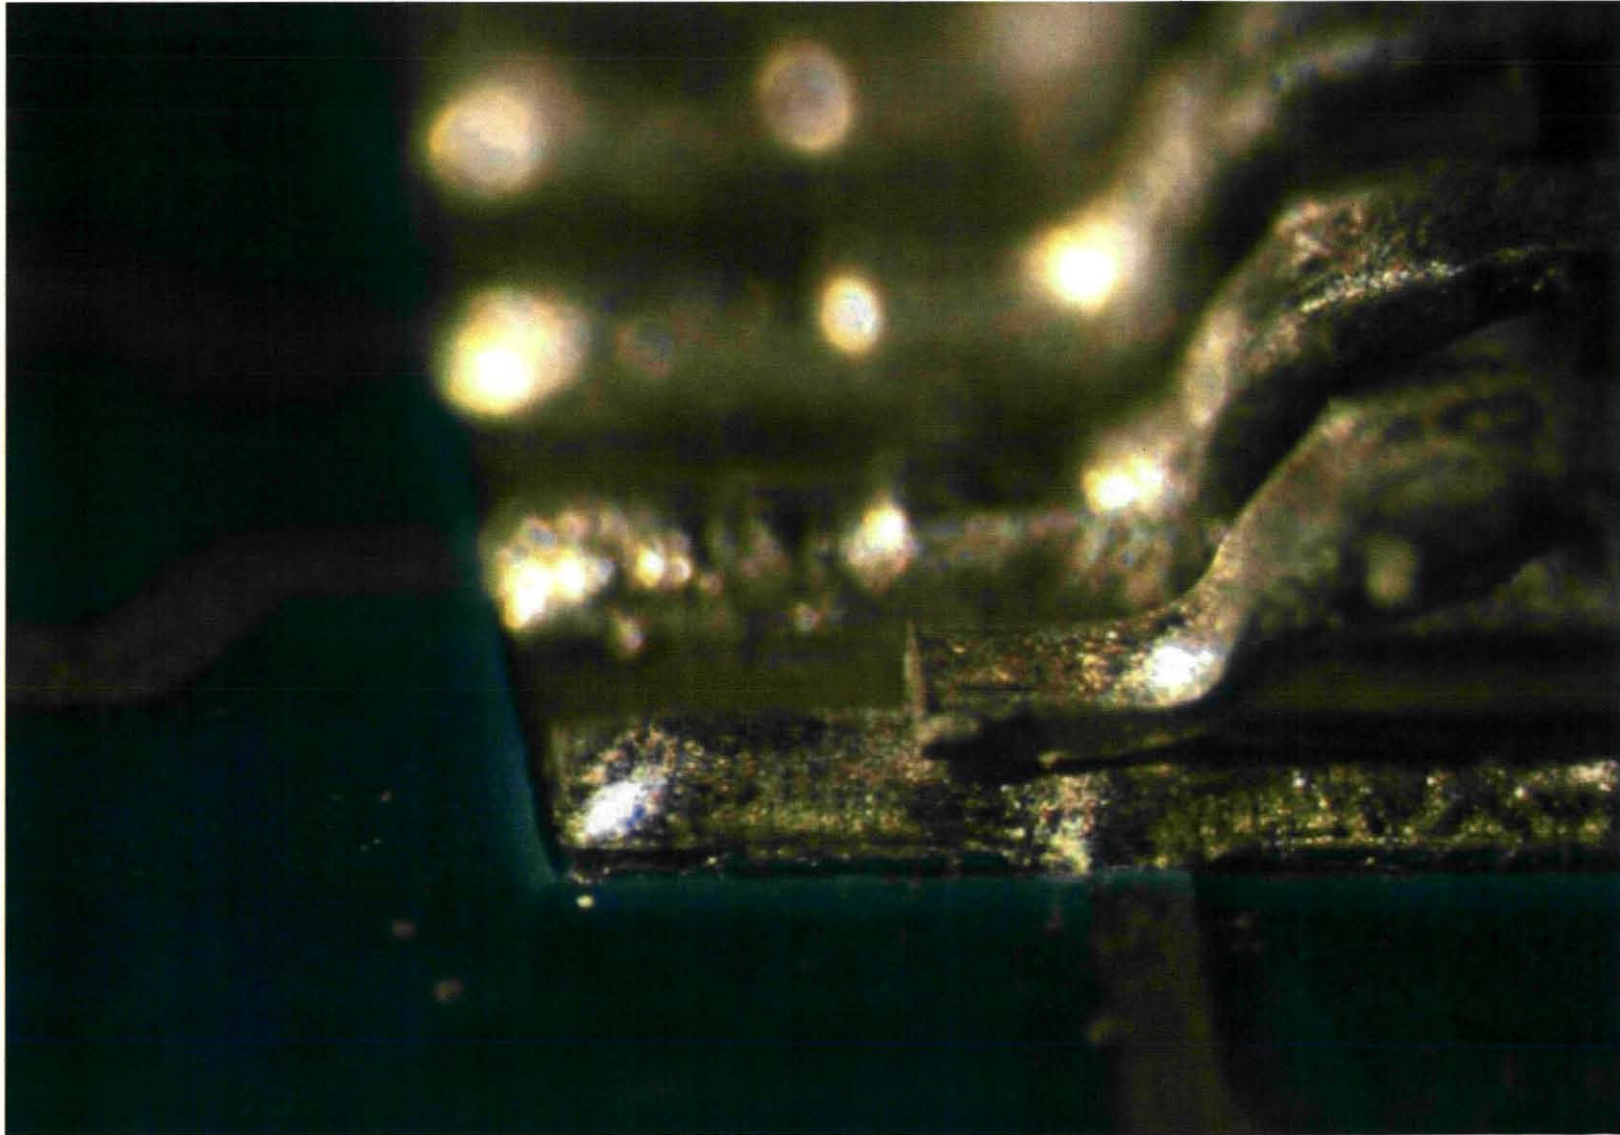
Test Vehicle 21; Component U34 – TQFP 144; Board Finish – Imm. Ag  
SnPb Manufactured (Batch C) - Solder (SnPb) - Component Finish (SnPb Dip): No  
signal, failed at 0 cycles

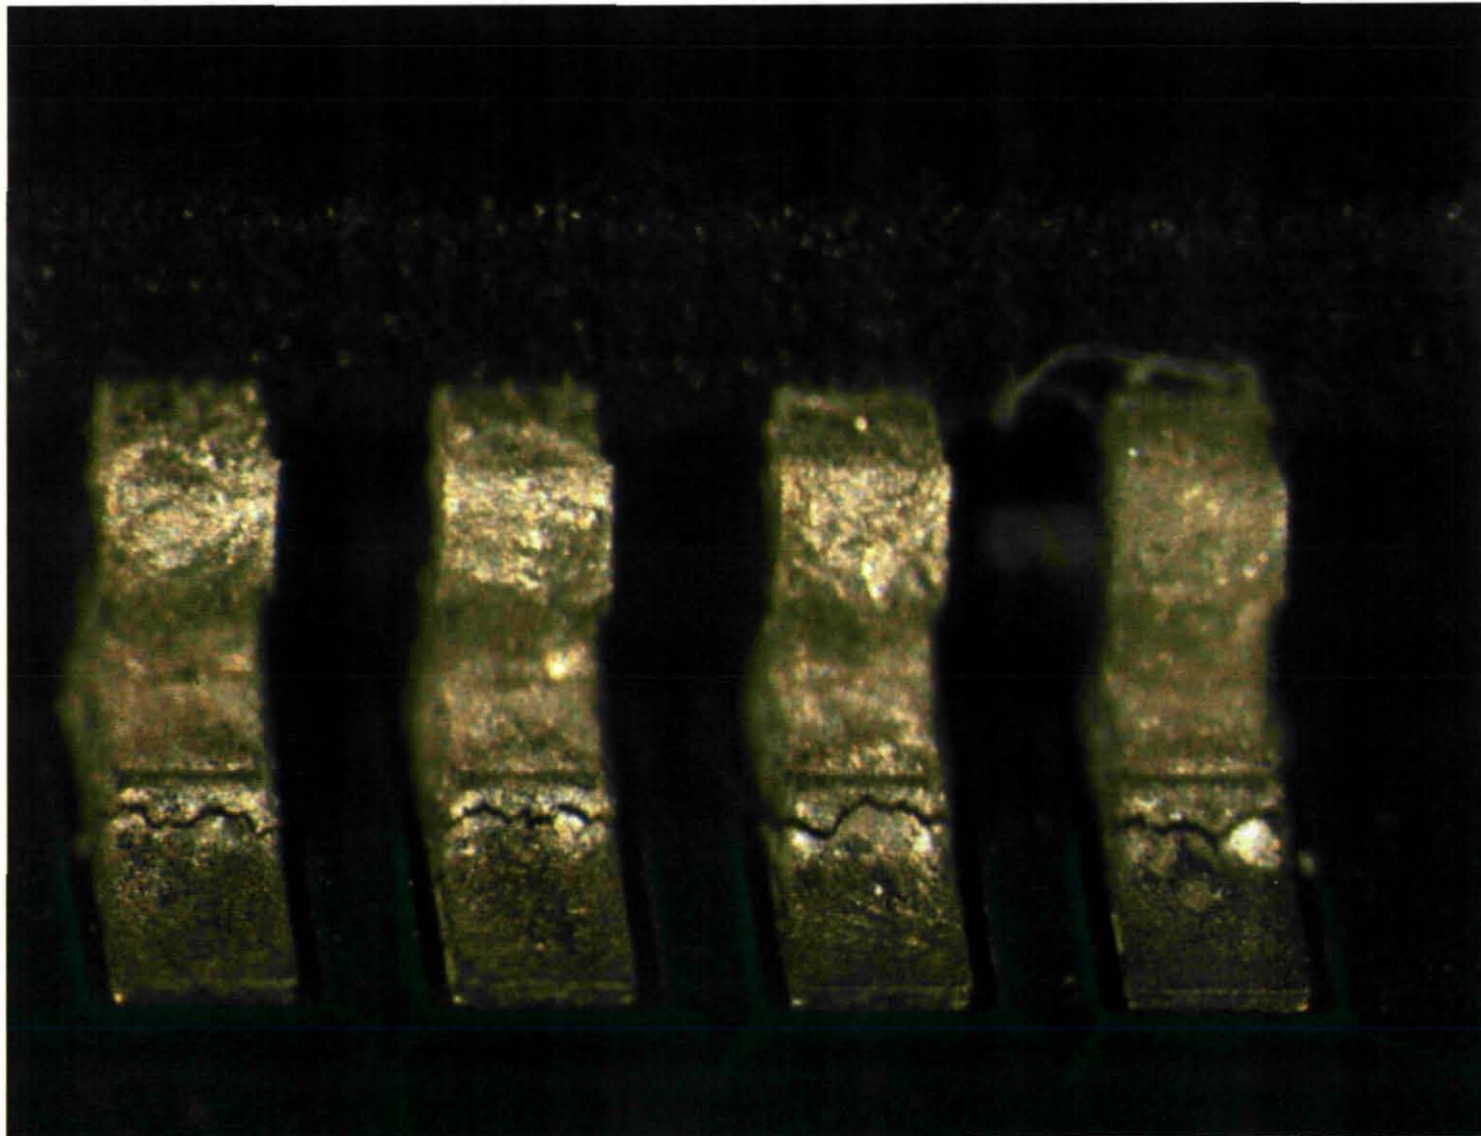
Test Vehicle 119; Component U39 – TSOP 50; Board Finish – Imm. Ag  
Lead-Free Manufactured (Batch G) - Solder (SN100C) - Component Finish (SnPb)  
Surrounded by components that fell off; failed at 318 cycles

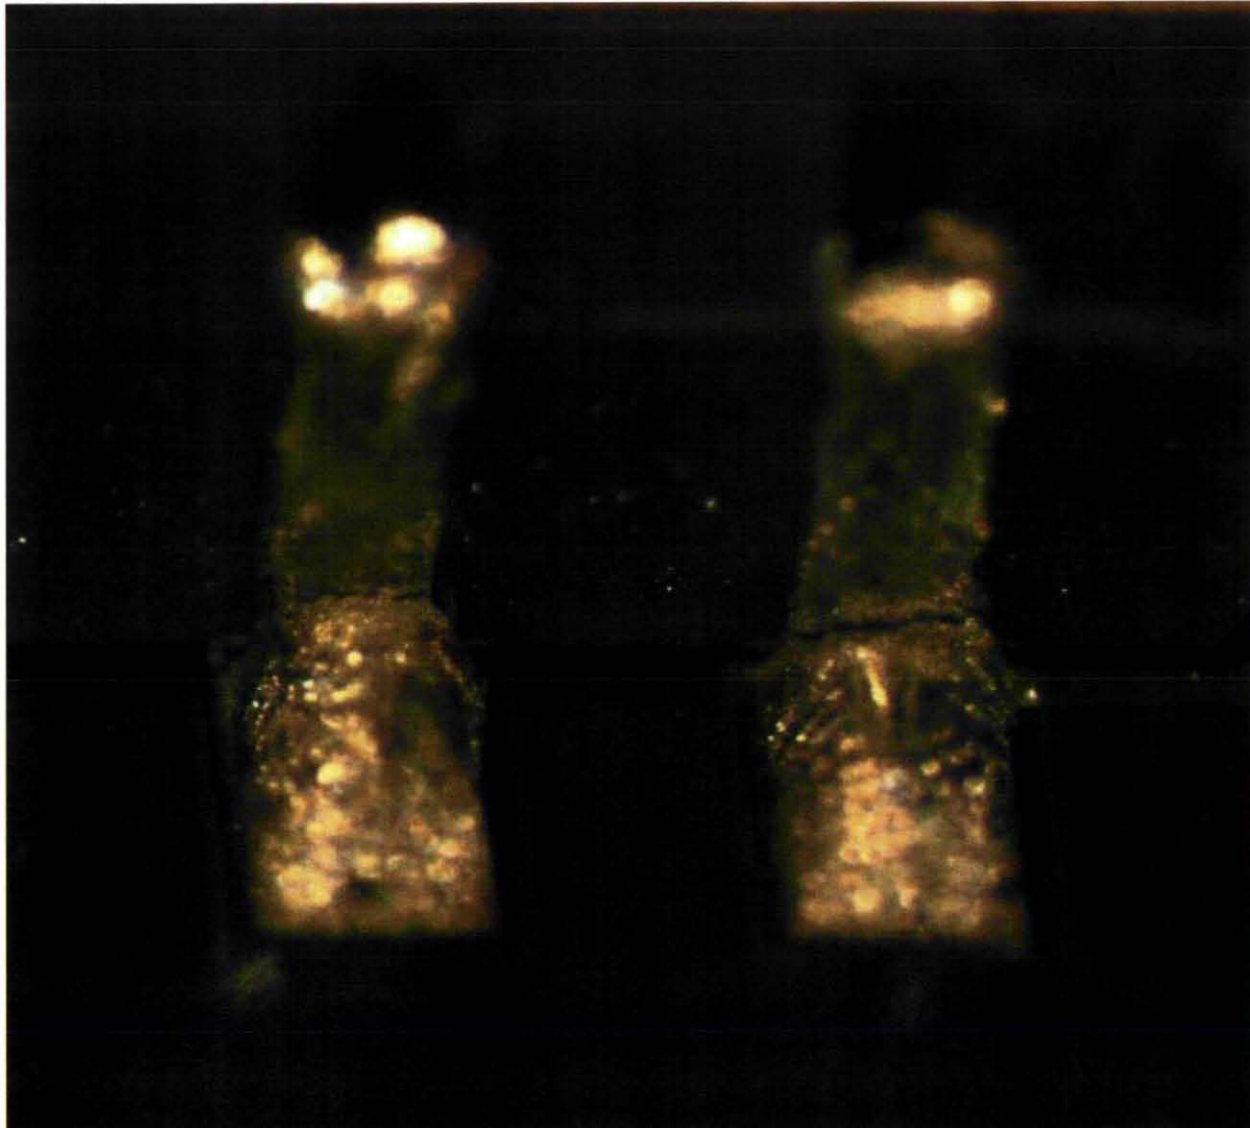
Test Vehicle 142; Component U13 – CLCC; Board Finish – Imm. Ag  
SnPb Rework (Batch B) - Solder (SnPb) - Component Finish (SAC305)  
Adjacent to reworked components, survived all 650 cycles

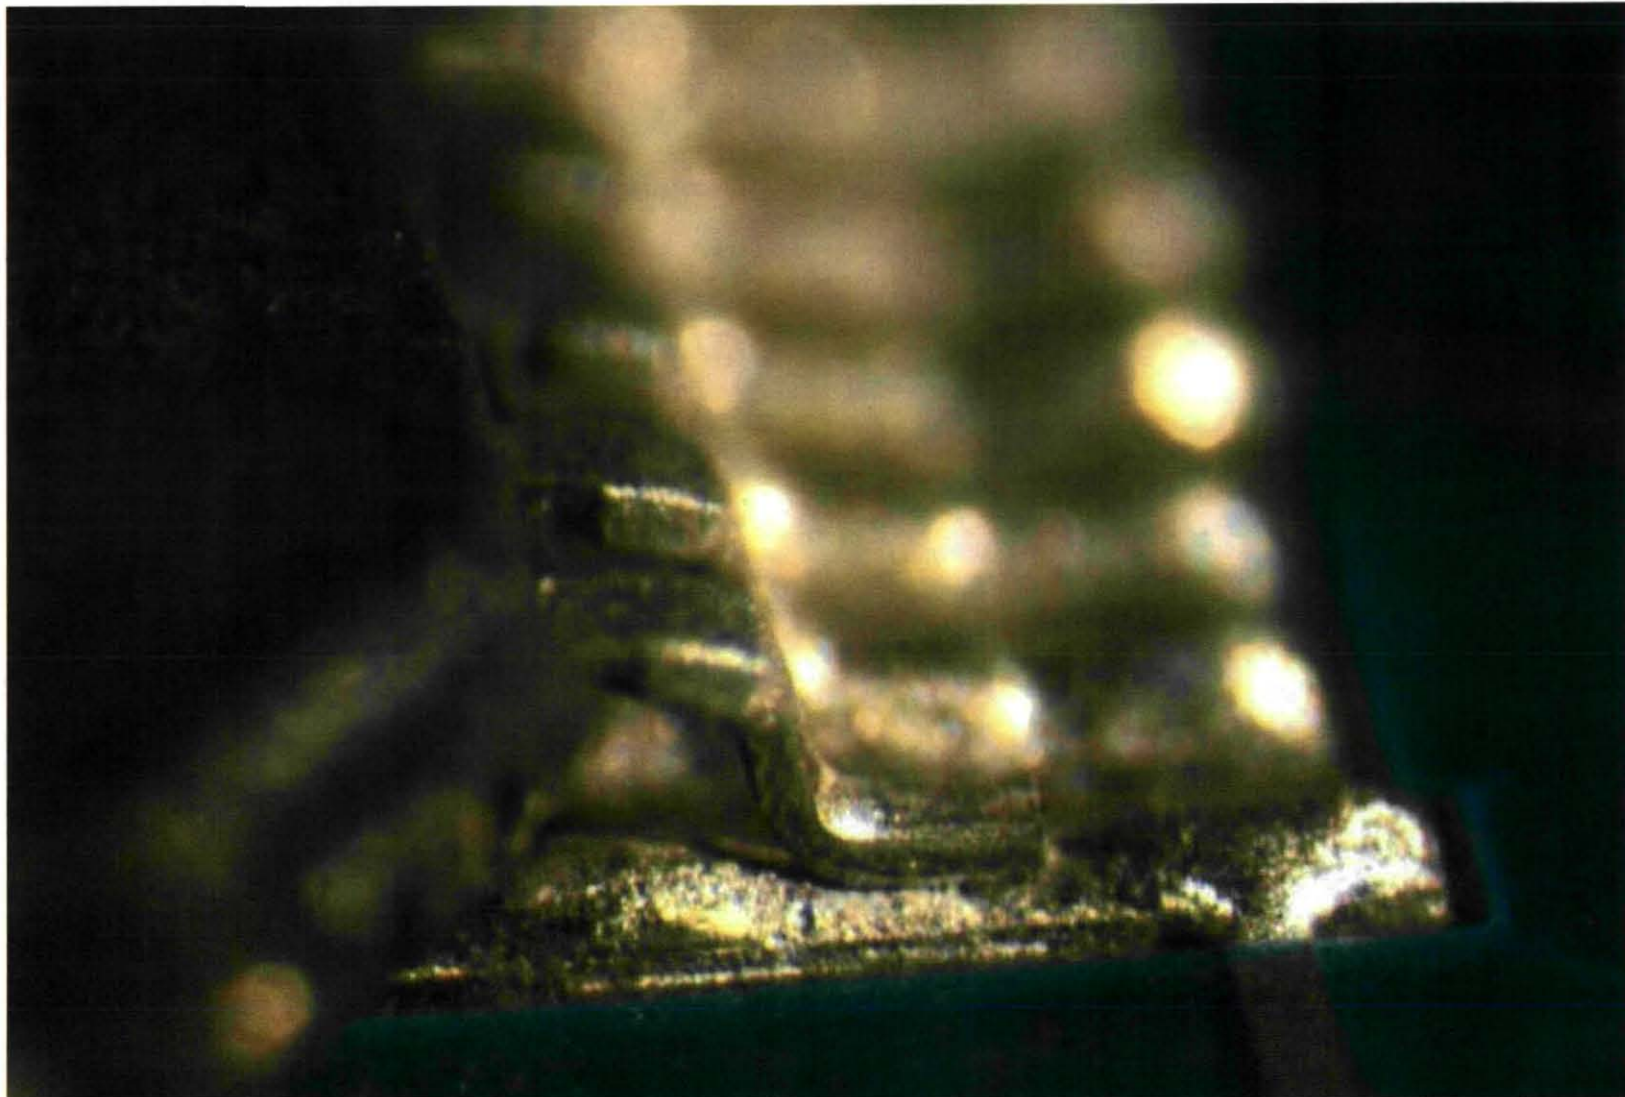
Test Vehicle 21; Component U57 – TQFP 144; Board Finish – Imm. Ag  
SnPb Manufactured (Batch C) - Solder (SnPb) - Component Finish (SnPb Dip)  
Failed at cycle 1

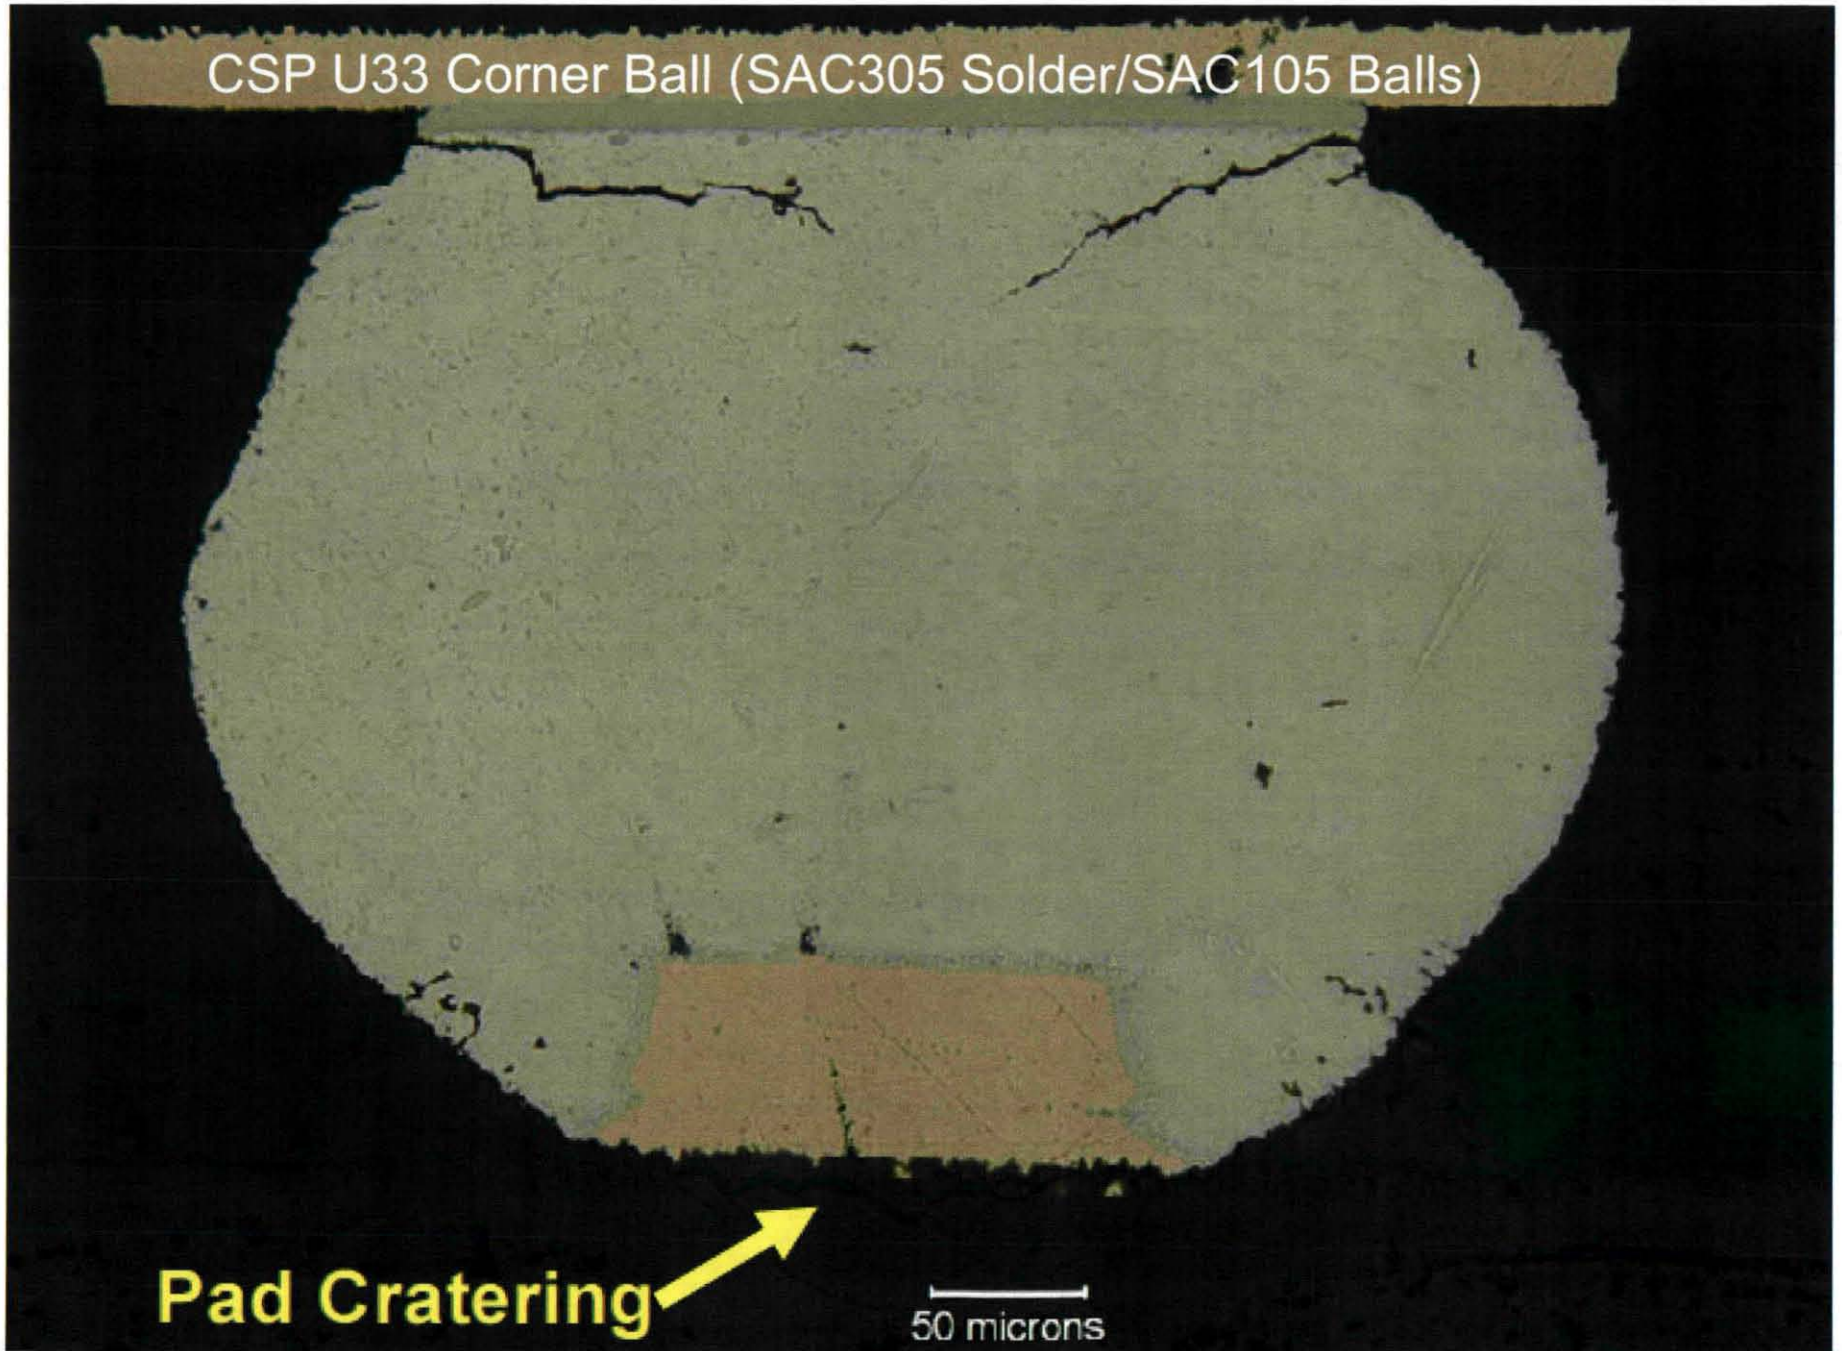
CSP U33 Corner Ball (SAC305 Solder/SAC105 Balls)

**Pad Cratering**

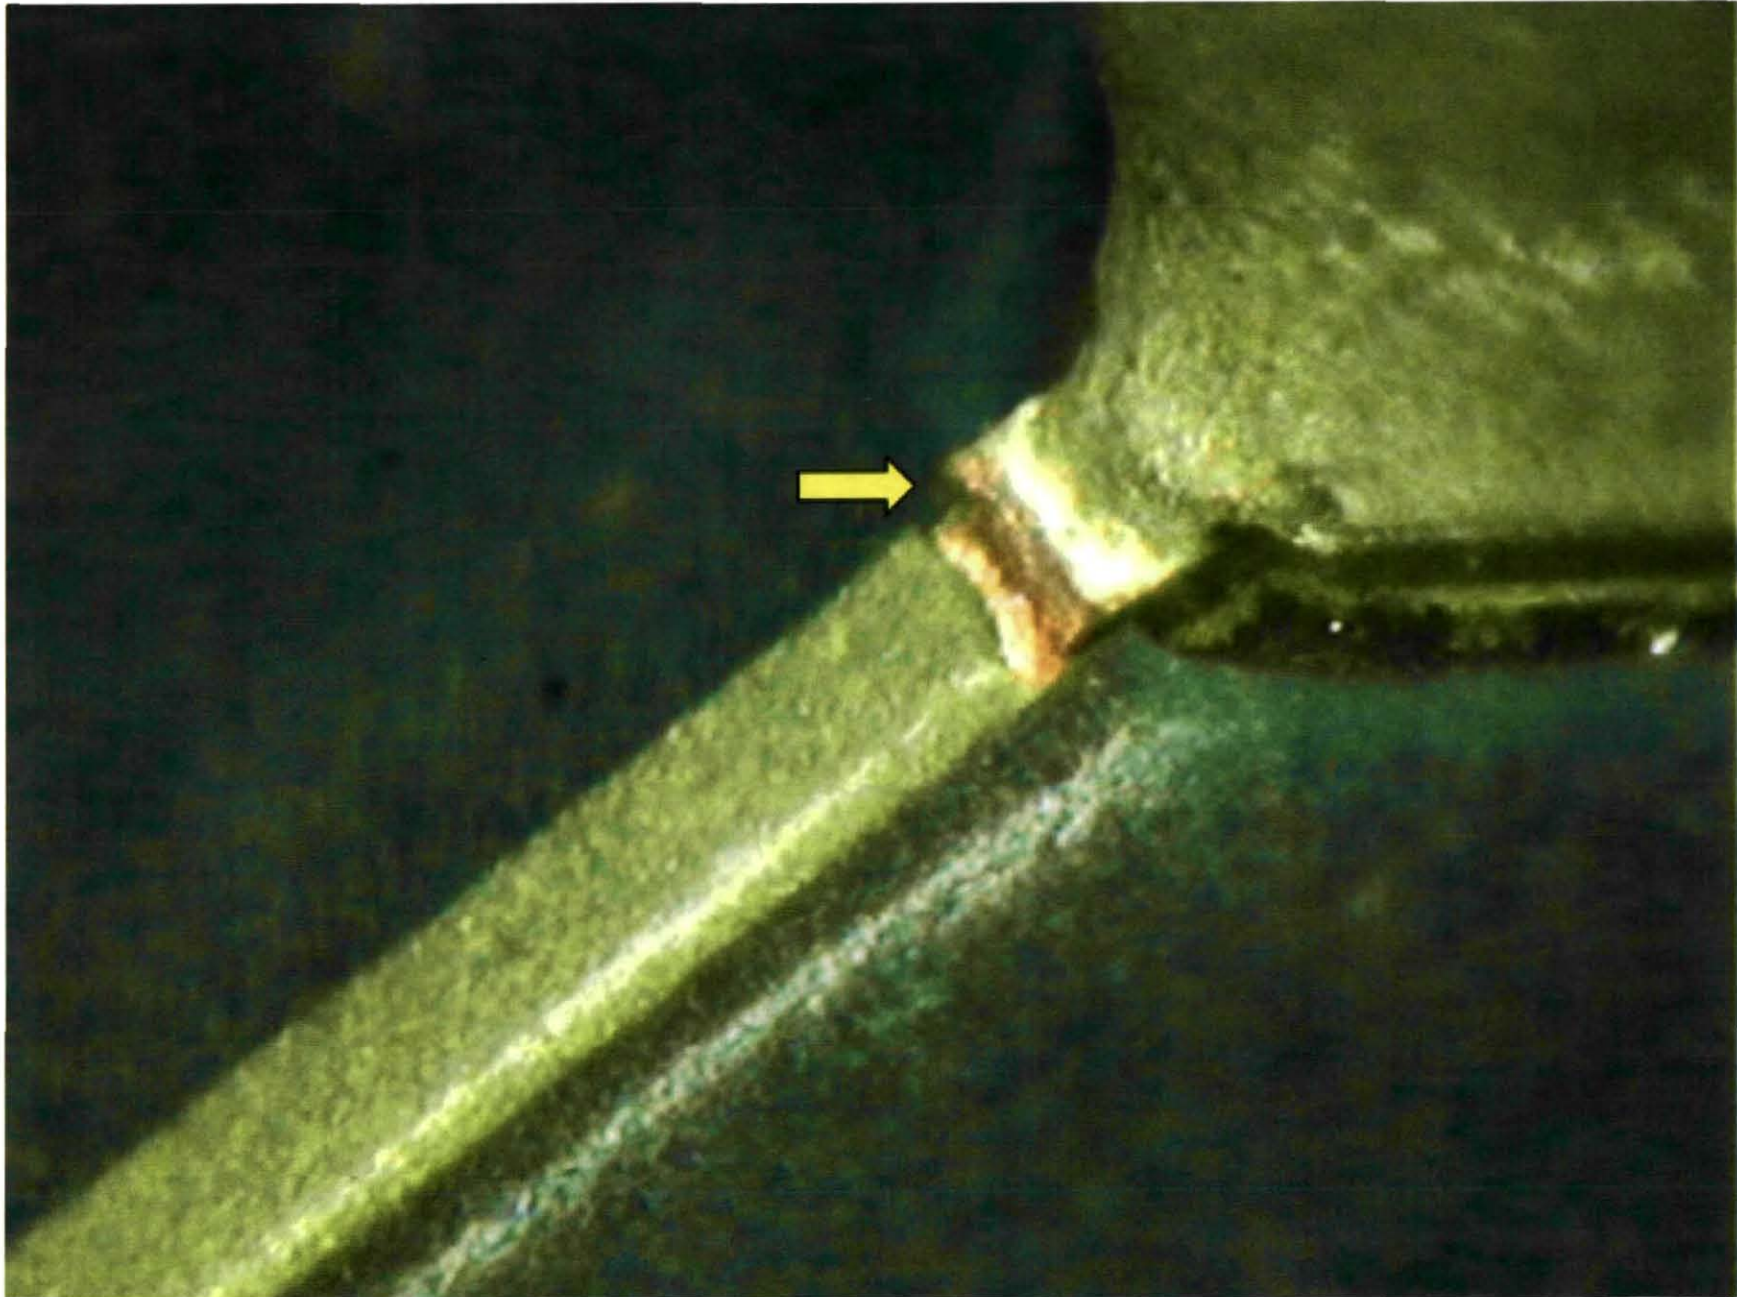
PDIP U38 Trace Crack (SN100C)

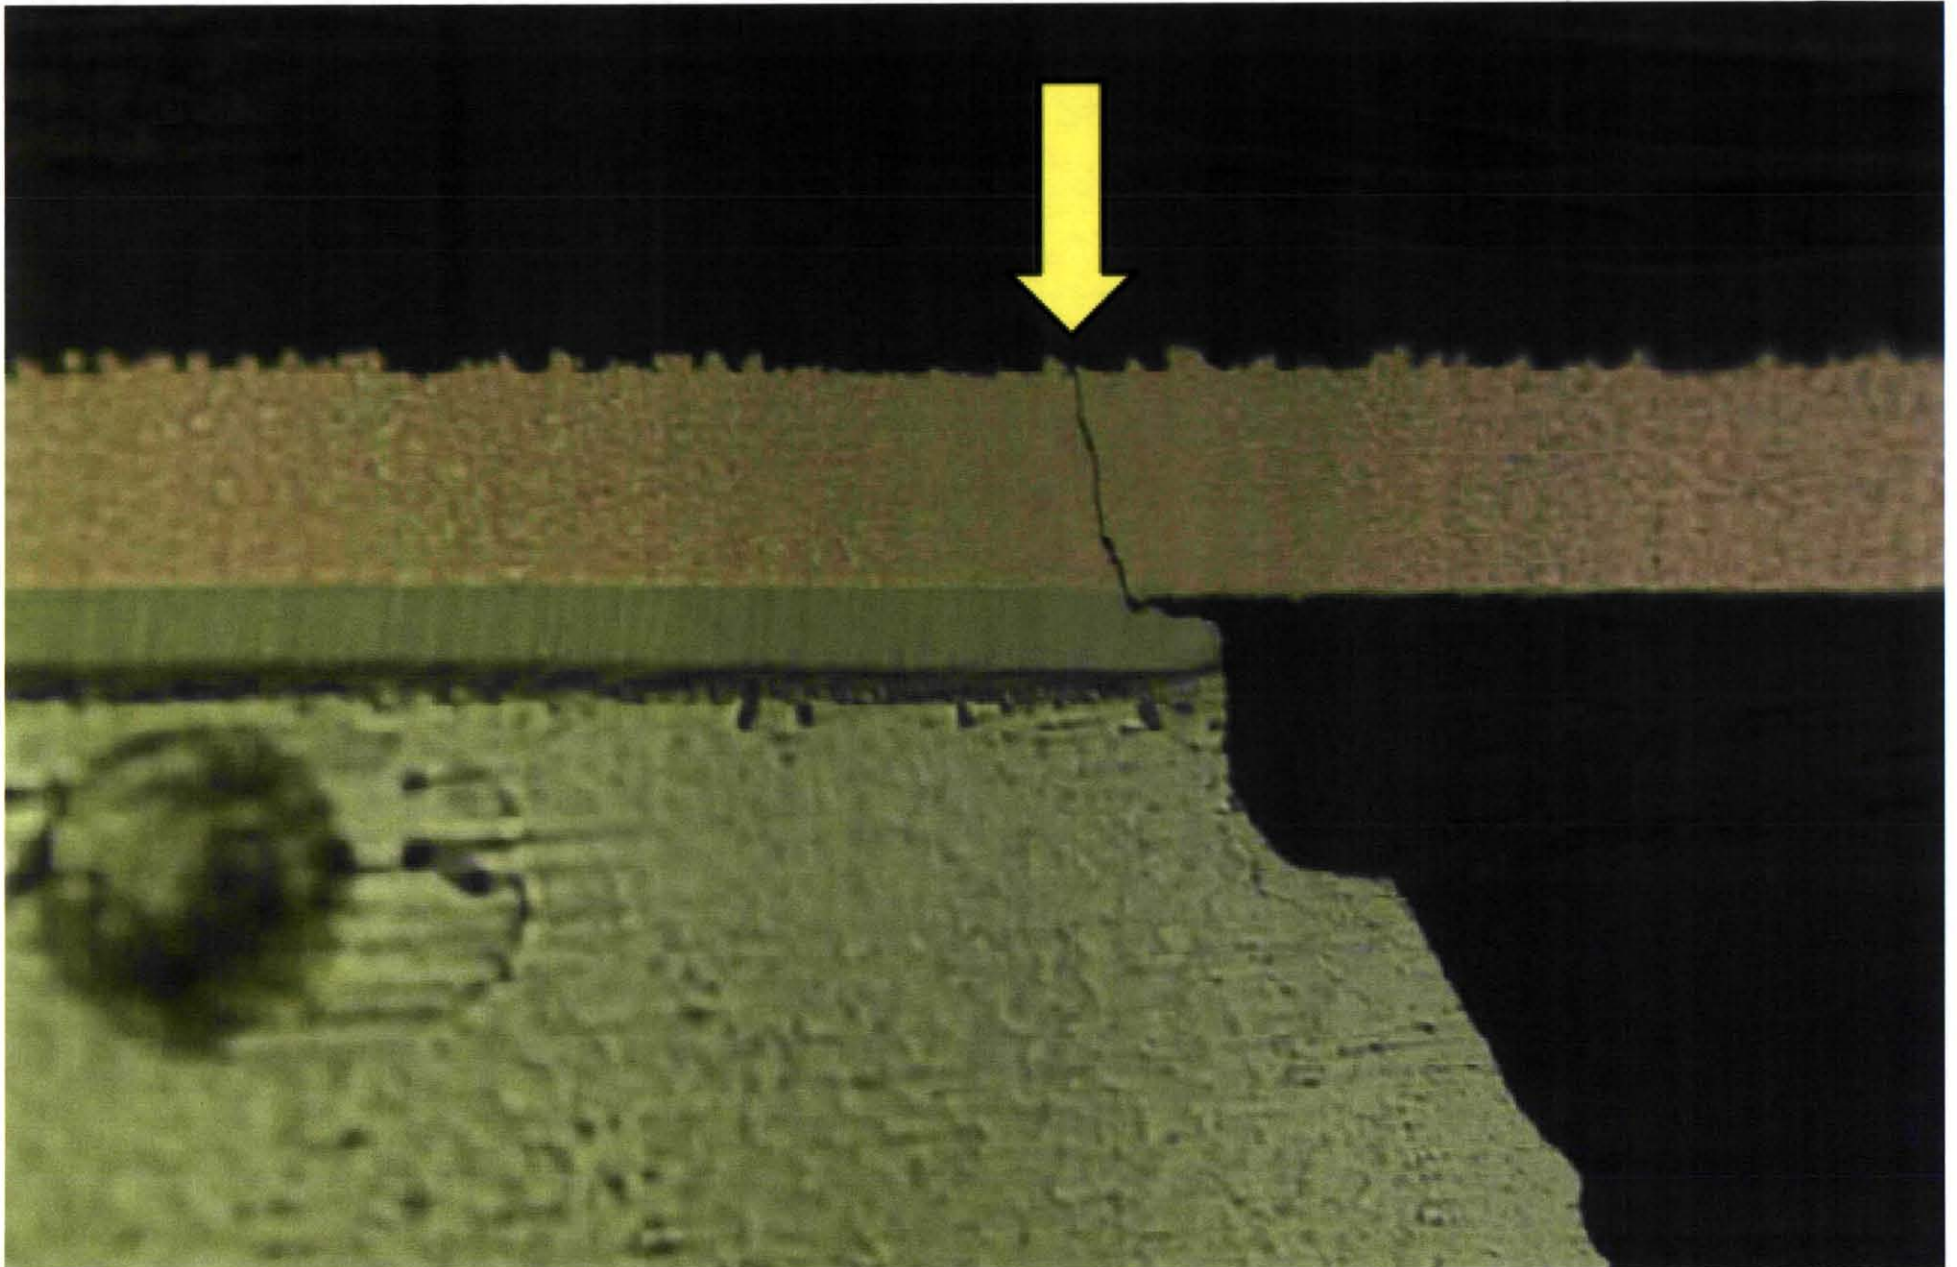
Test Vehicle 36 – Trace Crack on Component Side of BGA U21  
(SAC305 Solder/SAC405 Balls)

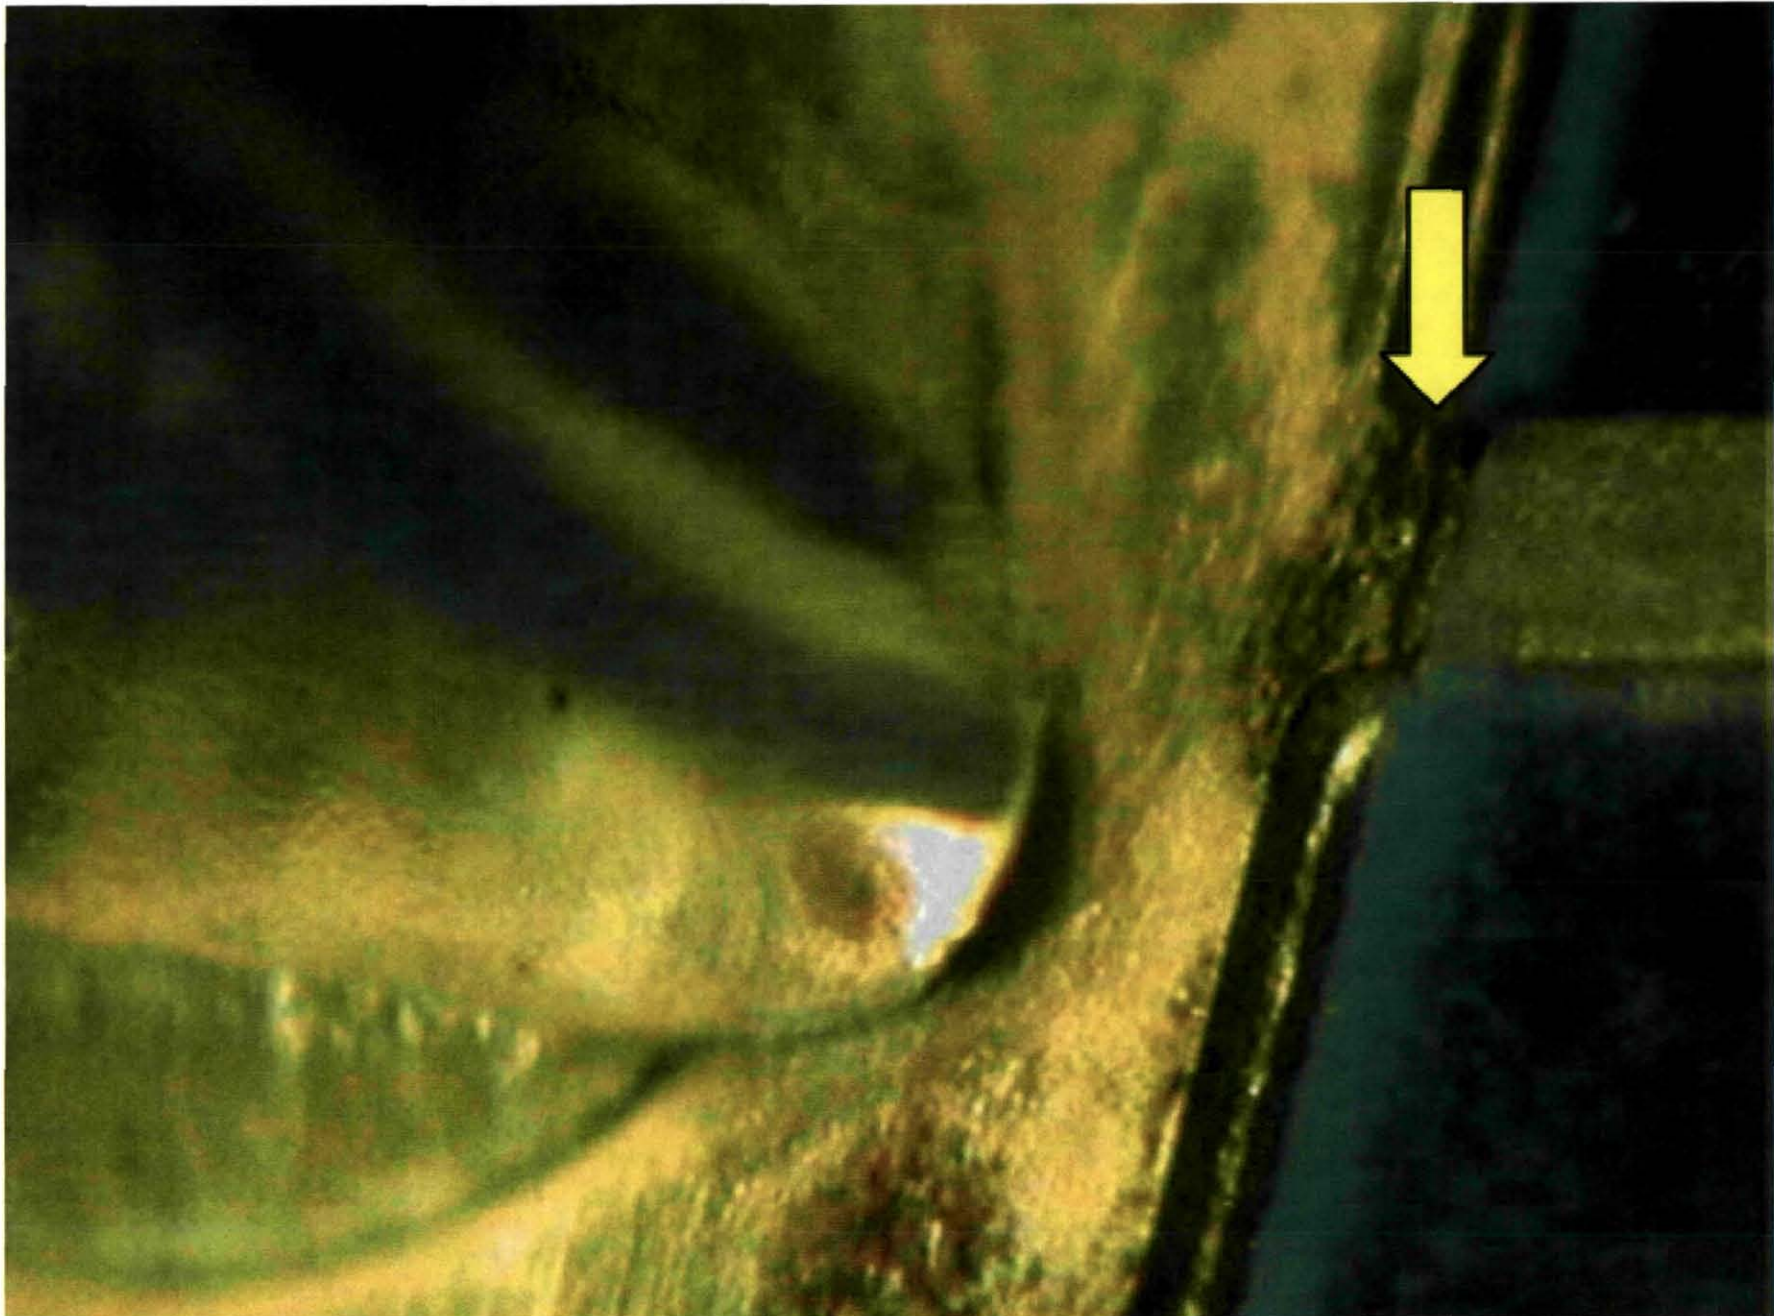
Test Vehicle 112 – Cracked Trace at Corner of PDIP U38 (SN100C/Sn)
